Section 3

Assessment & Analysis of

Land & Facilities

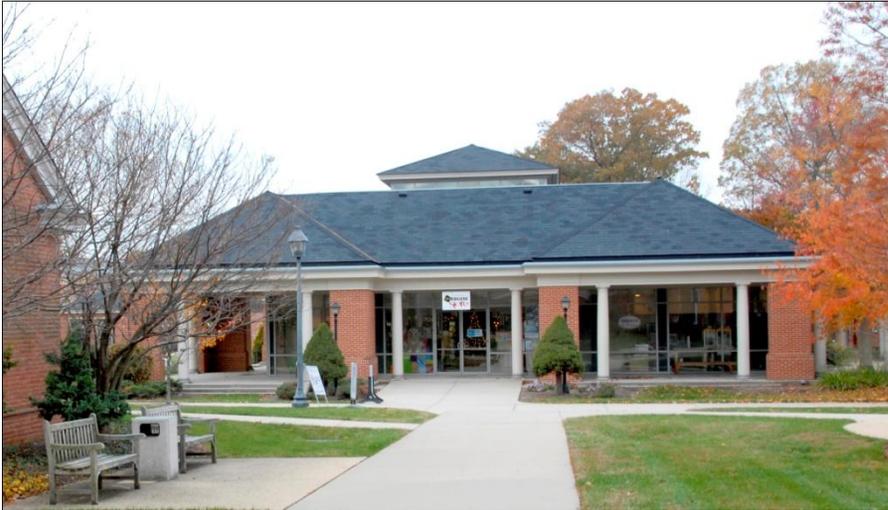
Bookstore (BK)

Deficiencies: The building is 20 years old and requires the following improvements: Replacement of the roof, HVAC, temperature controls, and upgrade of the lighting system with energy efficient lighting controls.

10-Year CIP: Replace roof, HVAC system, and lighting controls.

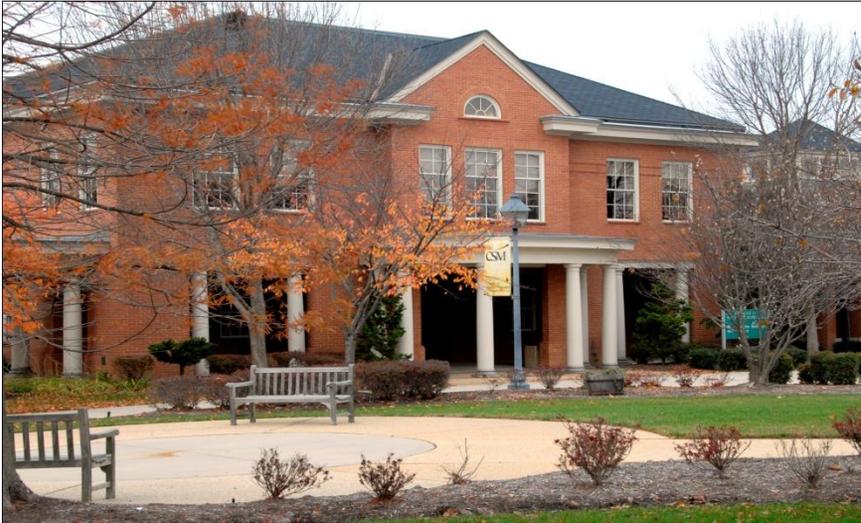
Center for Business and Industry (BI)

Deficiencies: An engineering study has determined that the HVAC system needs a major redesign due to the inability to control humidity levels. The current system does not provide sufficient control of temperature and humidity. Several fan coil units are inaccessible for maintenance and filter removal. The kitchen range and grill hood exhaust fans are located close to the outside air intakes causing food odors in the large conference room & other areas. The roof has deteriorated and requires replacement.

10-Year CIP: Funding will be requested during this time period to correct the deficiencies.

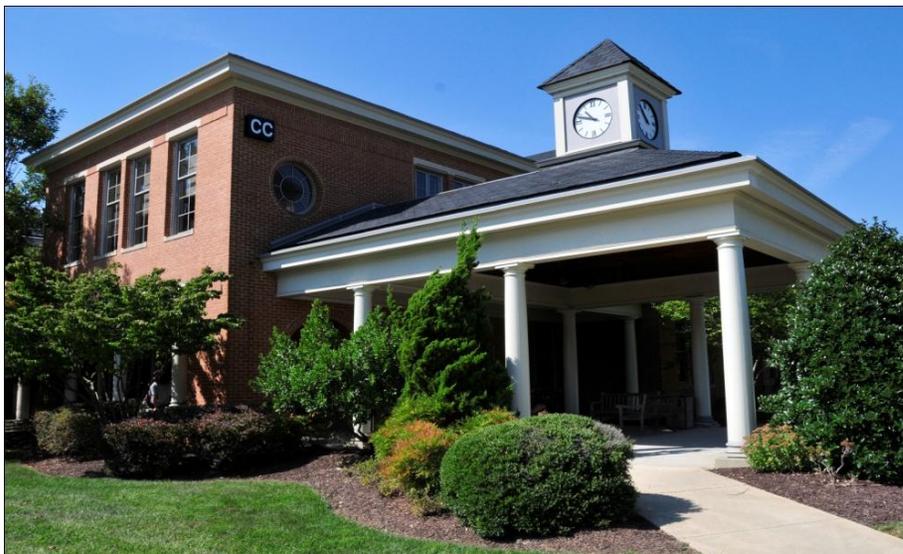
Campus Center (CC)

Deficiencies: It is recommended that the VAV box heat coils be correctly piped and heat coils be provided for VAV boxes not currently equipped with heat coils. In addition the automatic temperature controls should be replaced with direct digital controls and tied into the Campus EMS.

10 Year CIP: Building mechanical system is currently being reviewed to determine if items listed under *Deficiencies* can be corrected as normal maintenance or if a capital project is required.

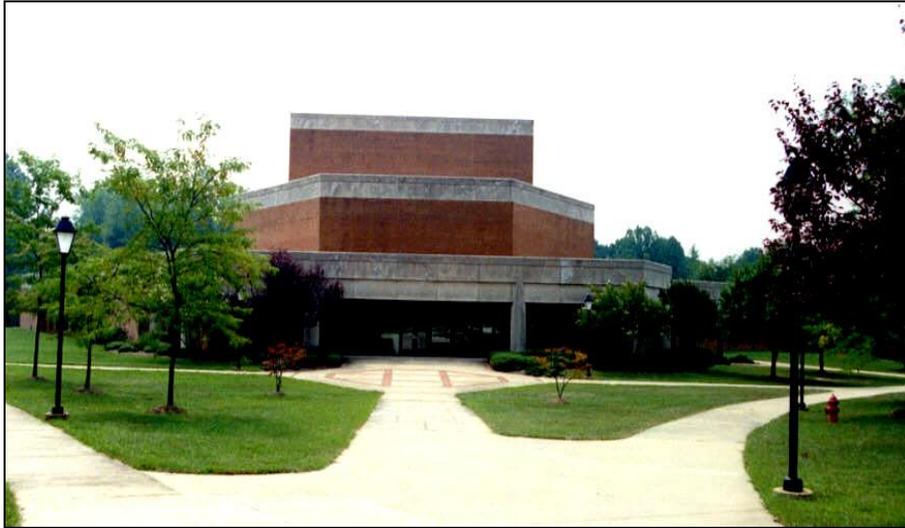
Fine Arts Center (FA)

- Deficiencies:** The building is 27 years old. It has water leaks in the kitchen and lobby areas. HVAC needs improvement in support areas. It is not possible to expand the current faculty office space. The rear stage area needs improved egress to meet current safety standards. Building needs an addition to accommodate a 150-seat black-box theater, sculpture area, and additional offices.

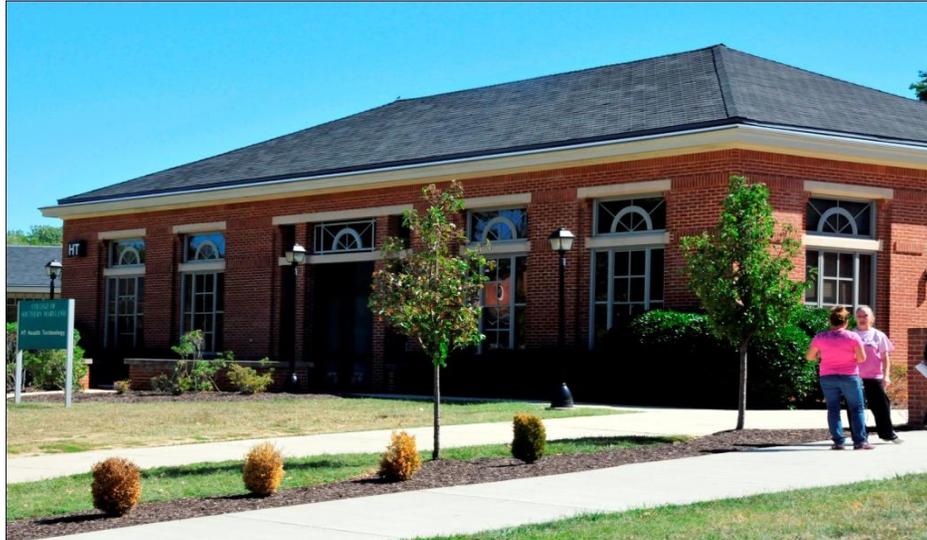
James C Mitchell Center for Health Technology (HT)

Deficiencies: The HVAC system needs replacement. The control system is antiquated and does not function properly. It is recommended that the control system be replaced in its entirety and be tied into the campus EMS.

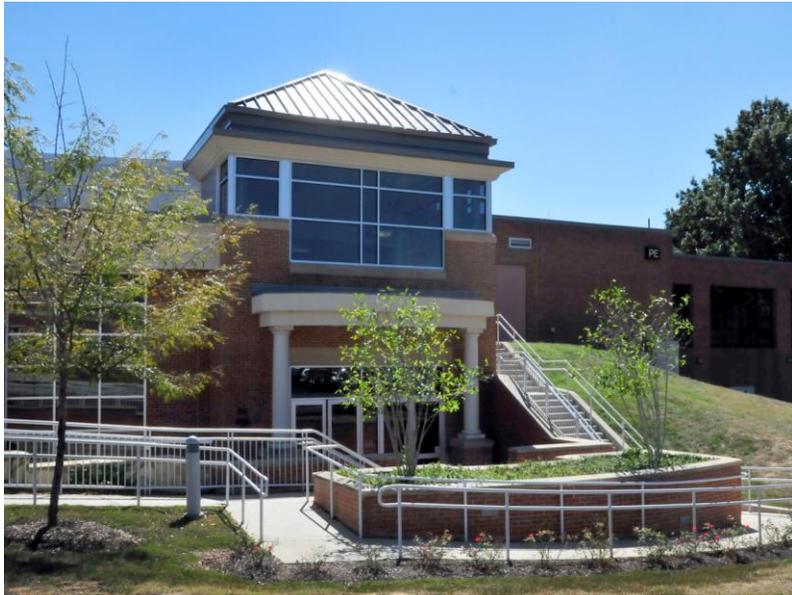
Physical Education (PE)

Deficiencies: Water drainage in the shower and dressing area is a problem.

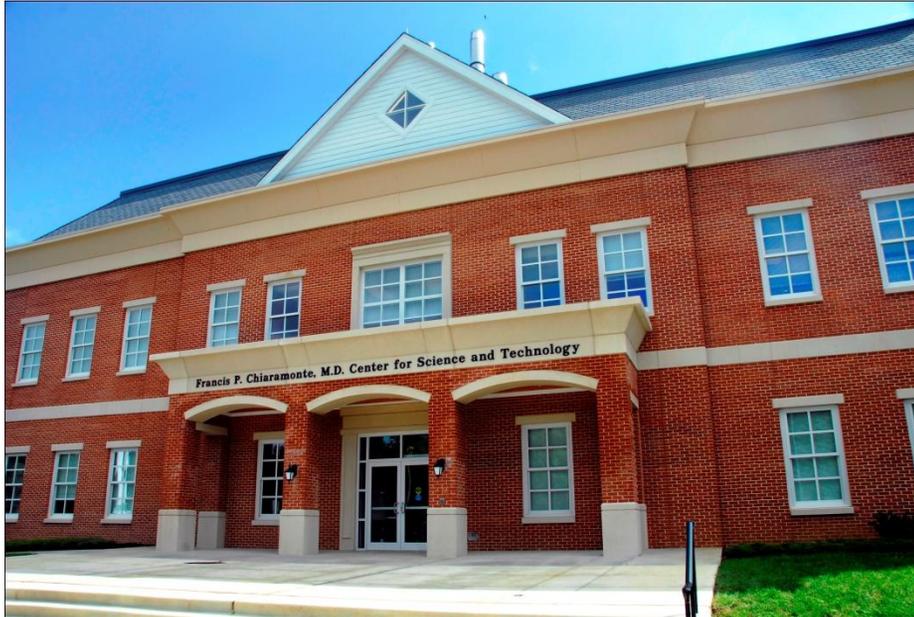
Francis P. Chiaramonte M.D. Center for Science & Technology (ST)

Deficiencies: The lower roofs need replacement.

10 Year CIP: Replacement of lower roofs.

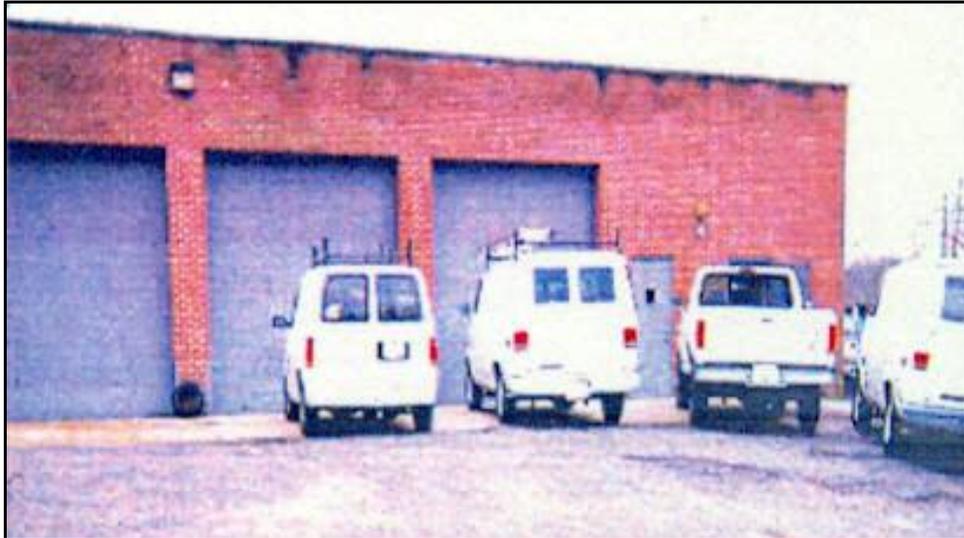
Maintenance Building (MT)

Deficiencies: The building is twenty-eight years old. The size of the maintenance building is inadequate to serve the needs of the College. Building requires general renovation and modernization.

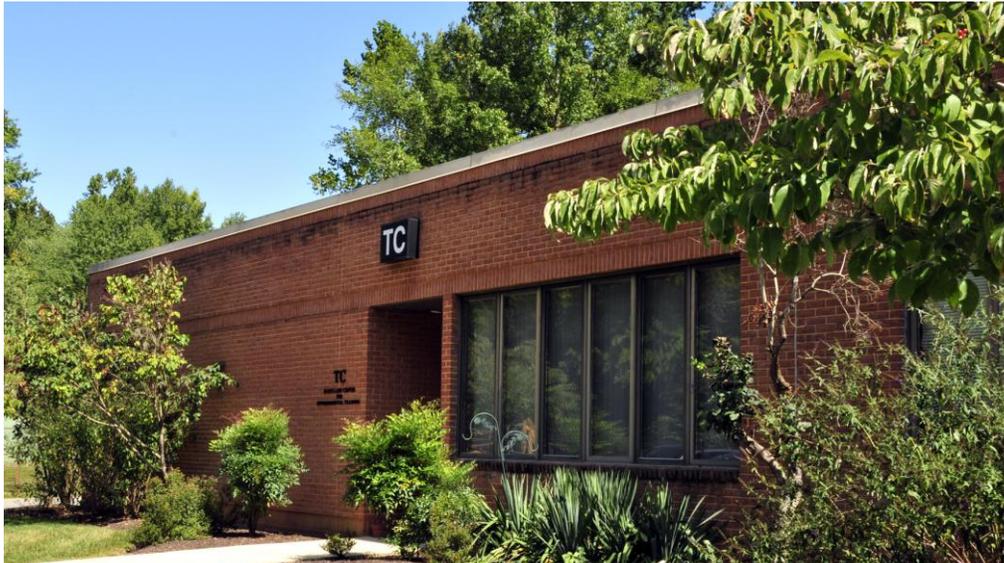
Maryland Center for Environmental Training (TC)

Deficiencies: The building is 27 years old. Classroom space is limited. There is no growth potential to accommodate additional training programs. Ceilings need replacement. Concrete floor is cracked in the vicinity of the electric room. Mechanical system and associated duct work needs updating and replacement.

ADA Compliant: Partially – It is not ADA compliant because it lacks panic hardware and the proper dimensions. Toilet facility entrances do not meet ADA recommendations in width. The parking lot for this building is not handicapped accessible.

10-Year CIP: Building should be renovated or replaced. Given the limited amount of assignable space renovation is not advisable. Consideration should be given to relocating the TC activities and converting the building to a maintenance facility.
