CCBC Facilities Master Plan 2016

CCBC Catonsville

February, 2016

Facilities Master Plan

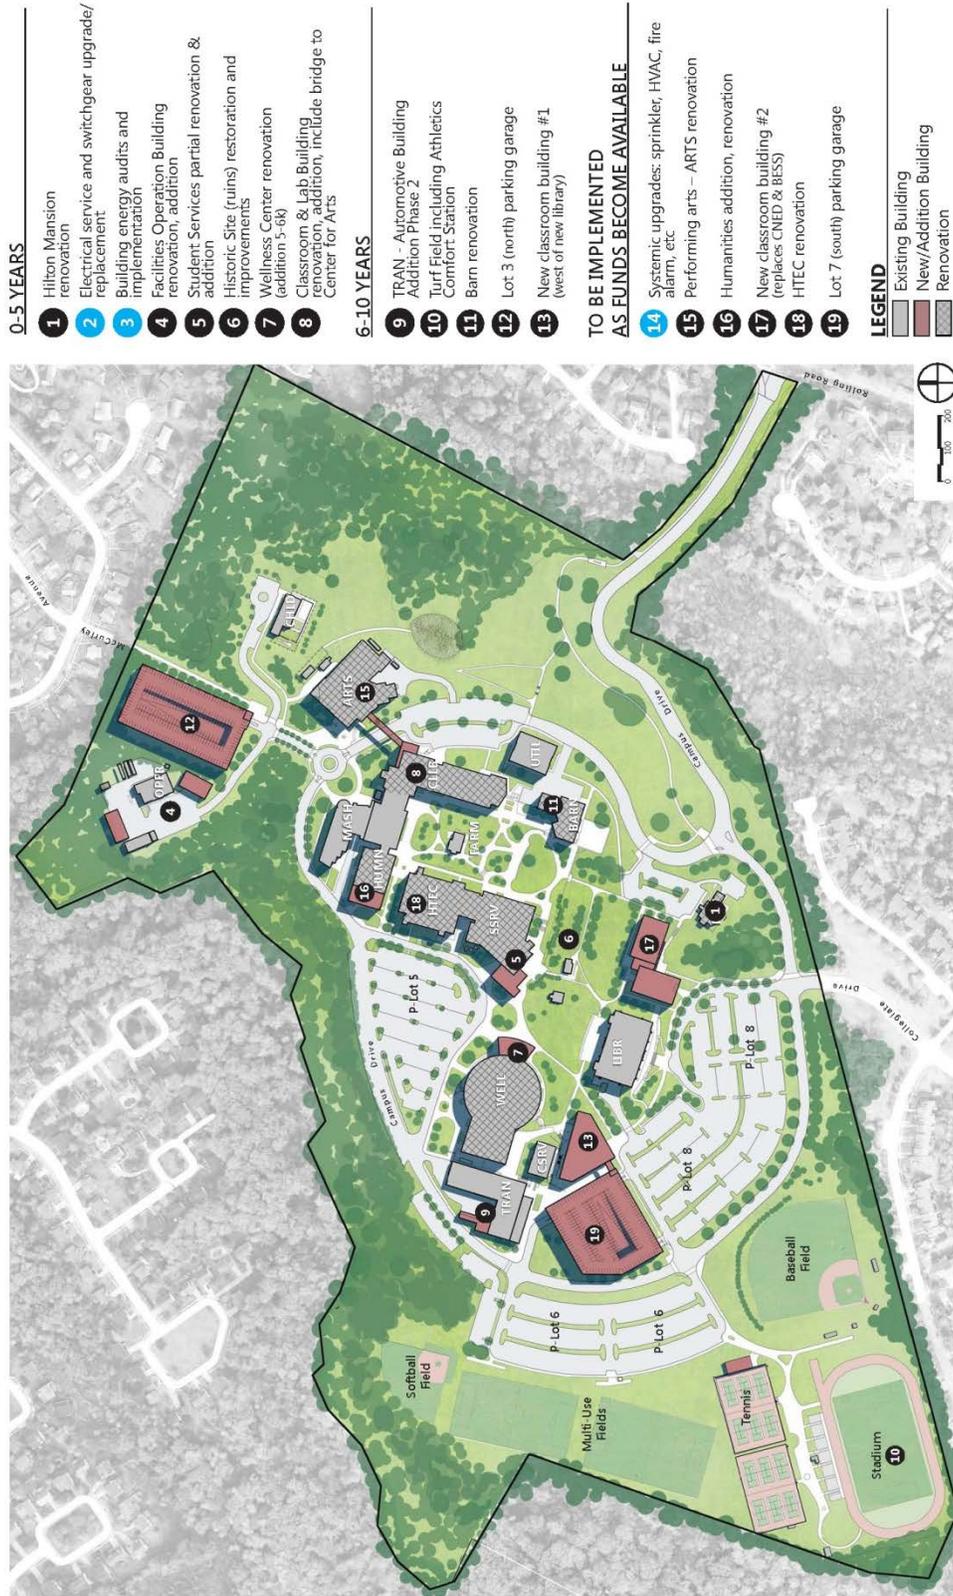
PROPOSED CAMPUS DEVELOPMENT – CCBC CATONSVILLE

- 1** Hilton Mansion renovation
- 2** Electrical service and switchgear upgrade/ replacement
- 3** Building energy audits and implementation
- 4** Facilities Operation Building renovation, addition
- 5** Student Services partial renovation & addition
- 6** Historic Site (ruins) restoration and improvements
- 7** Wellness Center renovation (addition 5-6k)
- 8** Classroom & Lab Building, renovation, addition, include bridge to Center for Arts

- 14** Systemic upgrades: sprinkler, HVAC, fire alarm, etc.
- 15** Performing arts – ARTS renovation
- 16** Humanities addition, renovation
- 17** New classroom building #2 (replaces CNED & BESS)
- 18** HTEC renovation
- 19** Lot 7 (south) parking garage

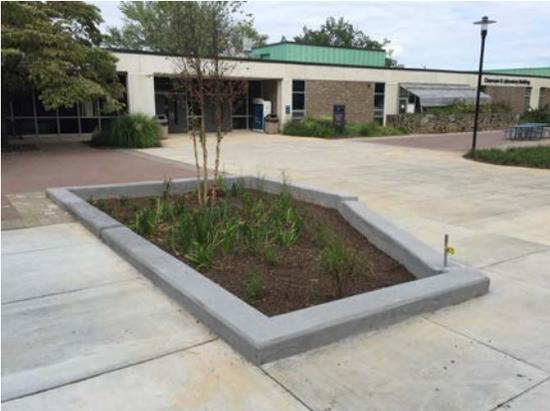
Recent Storm Water Management ESD facility

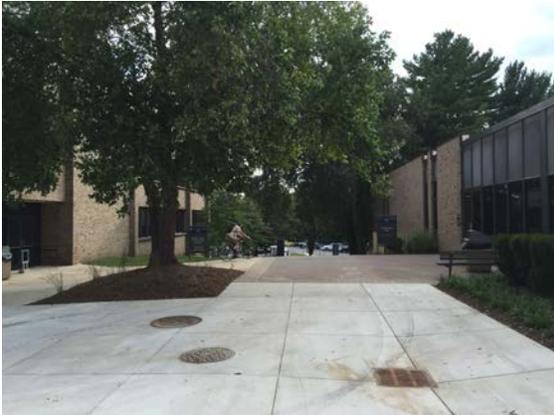
Recent Paving replacement throughout campus
